## Application Case Study – TRW Automotive, Shanghai, China

### Automated vision inspection and parts traceability in automotive assembly process

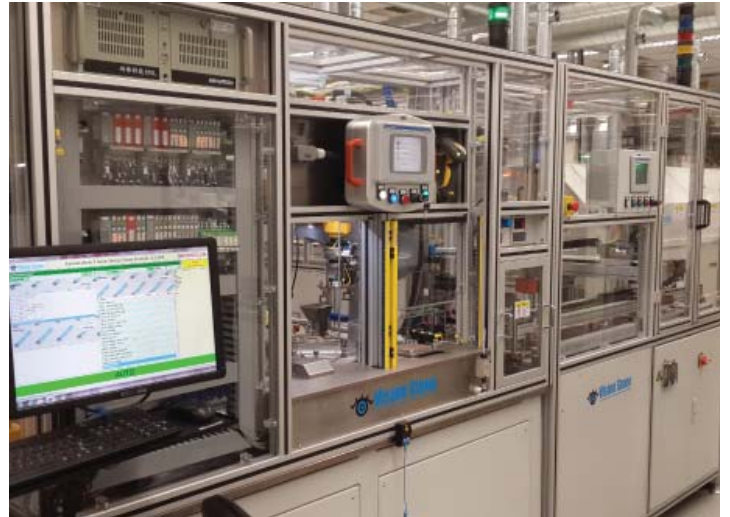
***Vision Stone developed and installed a custom-made vision inspection system for TRW with multiple smart cameras from Microscan.***

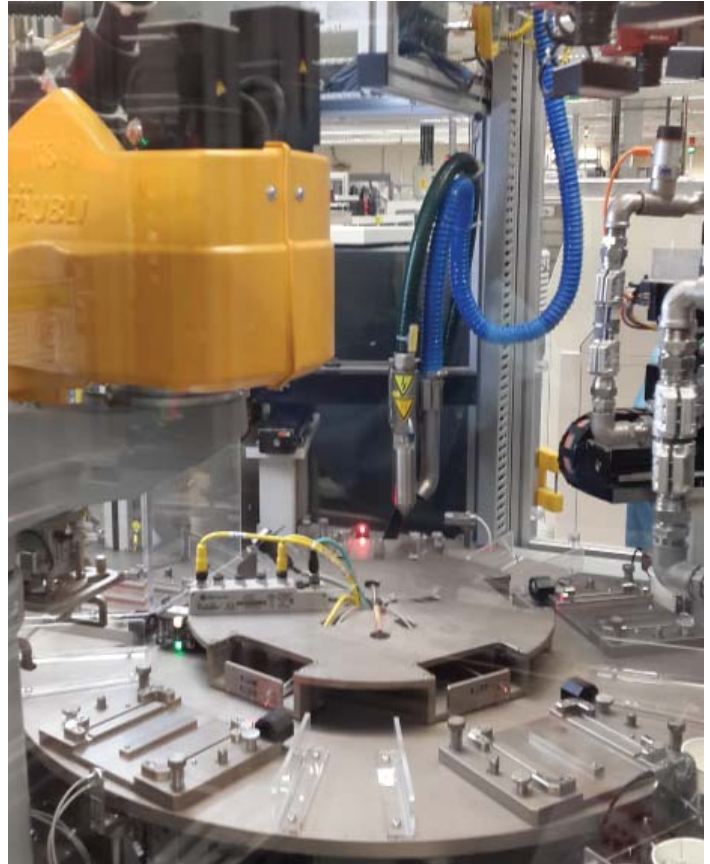
***Microscan's Vision HAWK is integrated into a robot arm for vision inspection on the assembly line.***

It checks that there are no air bubbles in the glue used for sealing to ensure coating integrity, before the products go into the oven.

In addition to making sure that the individual components are inserted into their correct positions, the vision system checks the solder position, the sealant and cooling gel position, and gel coverage rate on the cover. The cooling gel coverage is vital as too little of it will cause the parts to become too hot, and too much gel will affect the appearance. The components are also inspected to test for polarity, positioning or damage. The solder inspection is very important because if the stitch is even slightly bent, the product will be scrapped. Machine vision inspection of the sealant and cooling gel position will enable automated rejection of incorrect parts, without having to stop the assembly line.
